# **Biological investigation and monitoring tools used at a site with chlorinated ethylenes**

## **Cost effective remediation strategies based on biological monitoring**

**NICOLE conference “In situ measuring and  
monitoring: innovations and practical experiences  
for a cost effective approach”**

**Ir. Maurice Henssen  
Bioclear, The Netherlands**

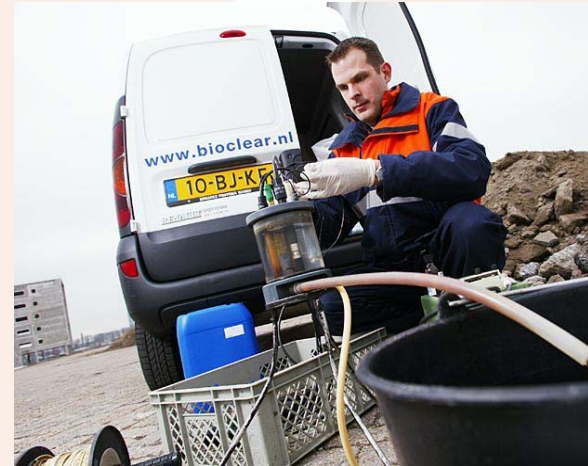
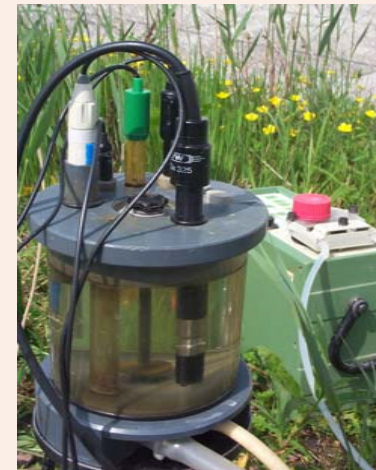
## 2. Groundwater characterisation

# Parameters in GWC:

BTEX Oil	PCE		BTEX Oil	PCE
<b>Redox parameters</b>			<b>Environmental parameters</b>		
Oxygen	+	+	Acidity (pH)	+	+
Nitrate	+	+	Conductivity	+	+
Iron	+	+			
Sulfate and sulfide	+	+	<b>Degradation products</b>		
Methane	+	+	TCE, DCE, VC, ethylene	-	+
Redox potential	+	+	Chloride	-	(+)
Hydrogen analysis	(+)	(+)	Phenols, benzoates	+	-
			Alkalinity (carbon dioxide)	+	-
<b>Carbon source</b>			Isotope analysis	+	+
DOC/TOC	-	+			
			<b>Bacteria</b>	-	+
<b>Nutrients</b>					
Ammonium	+	+			
Phosphate	+	+

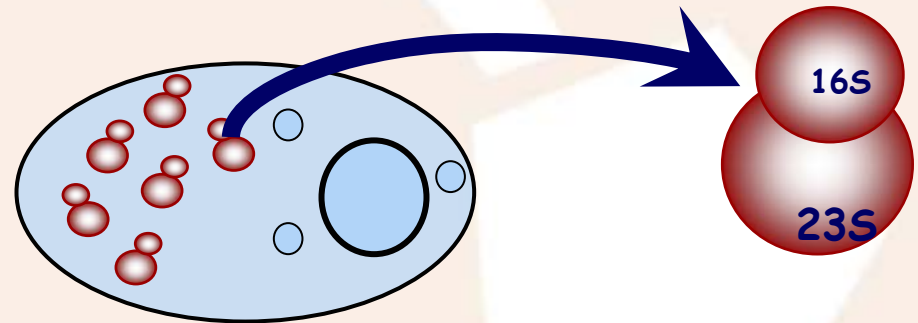
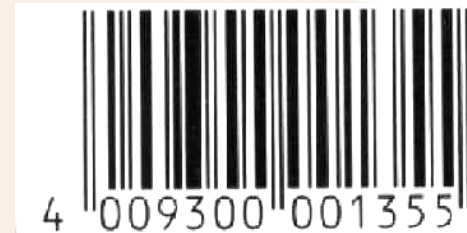
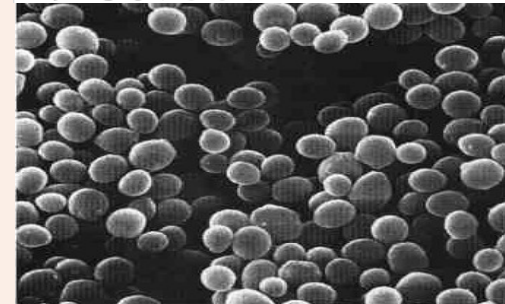
## 4. Molecular microbial analyses

**Specific DNA**

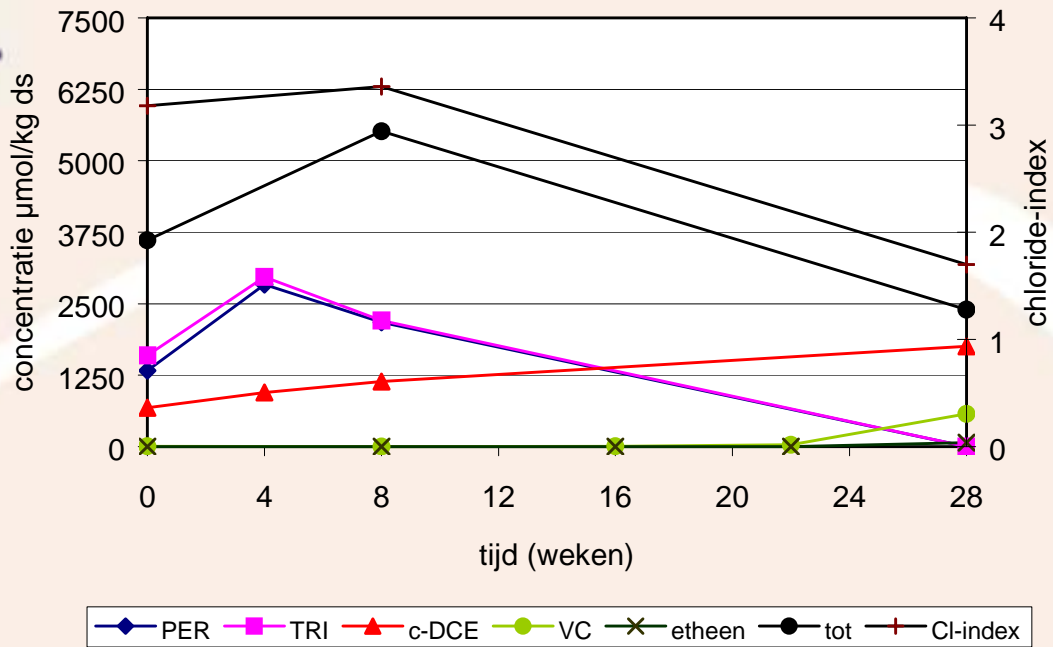
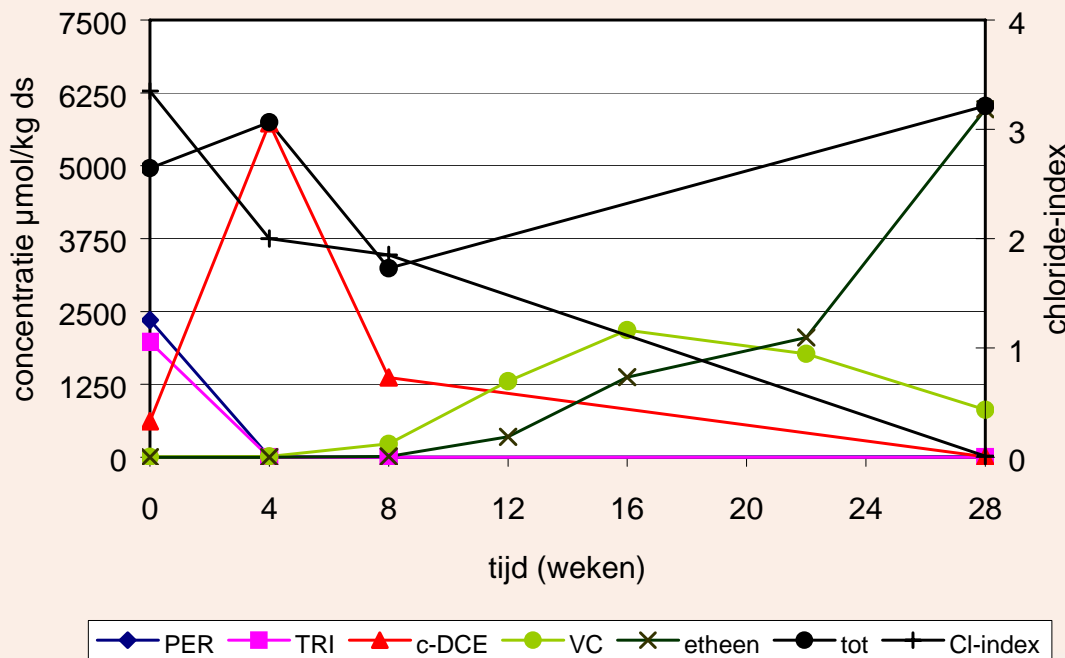
**Acceleration enhanced vs NA:  
Lab factor 20,  
Field factor 4-5**

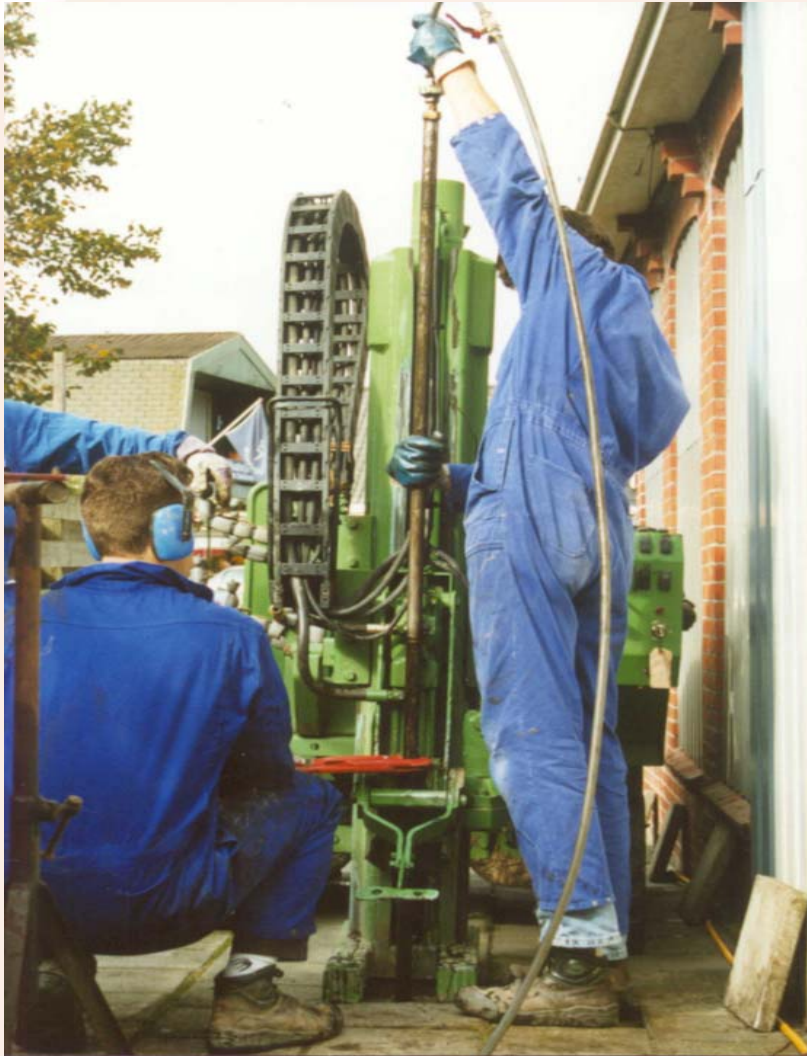
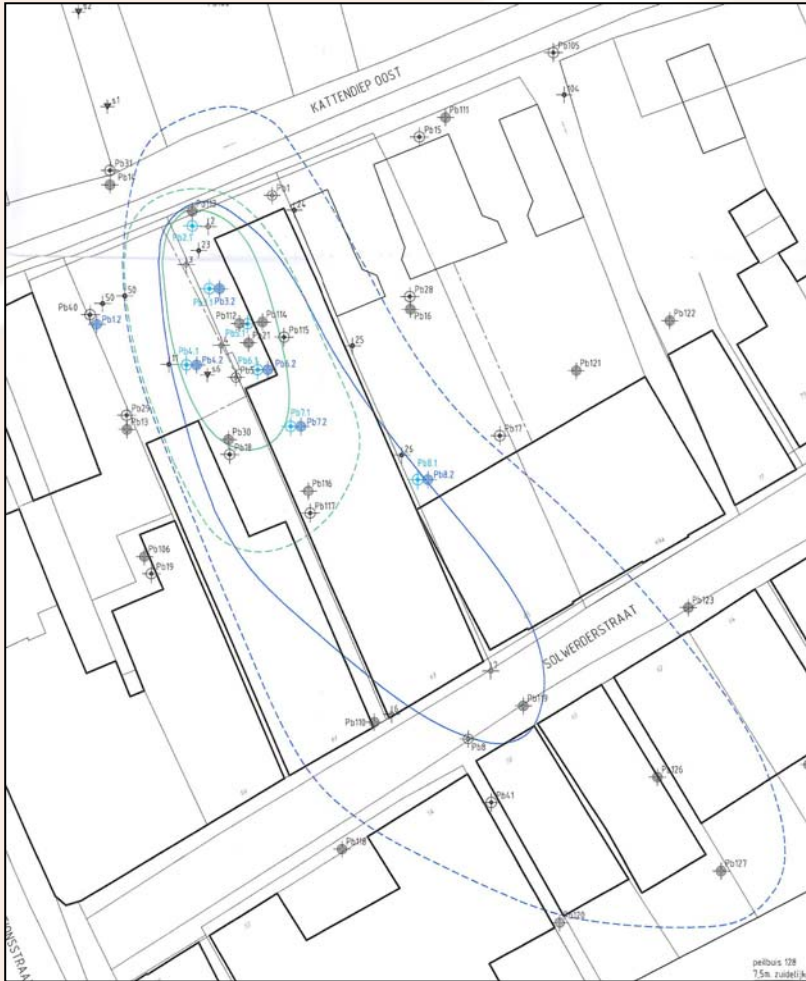
# Cost effective remediation: Enhanced degradation PCE in source zone

**Direct injection  
of carbon source  
(lactate and molasses)  
and nutrients**

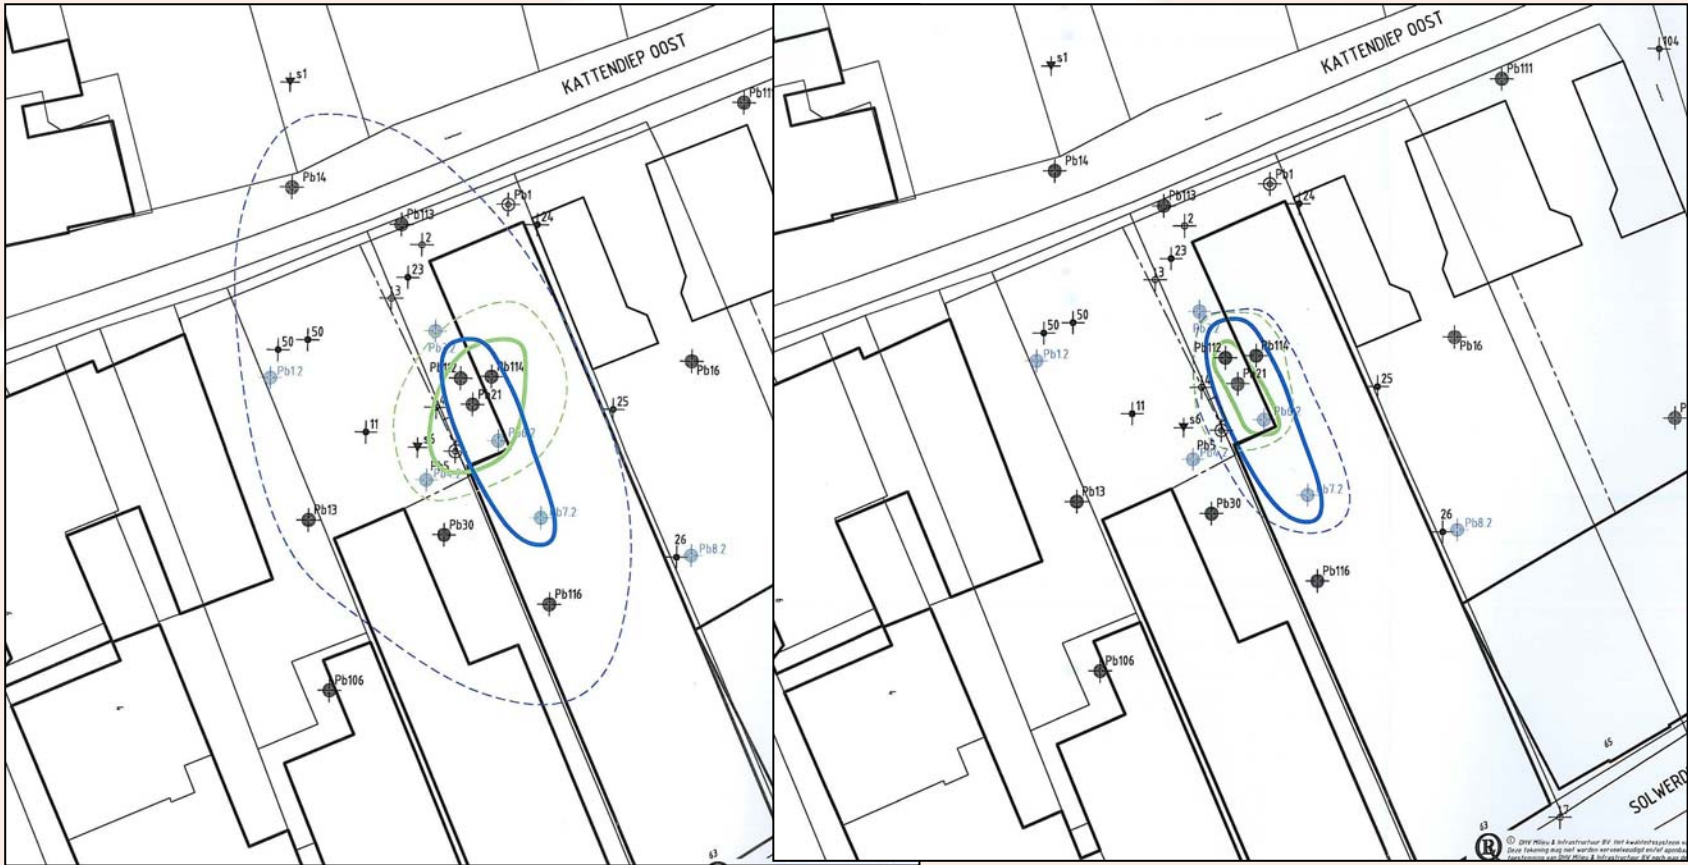
2003

- globale interventiewaardecontour tetrachlooretheen
- globale streefwaardecontour tetrachlooretheen
- globale interventiewaardecontour vinylchloride
- globale streefwaardecontour vinylchloride

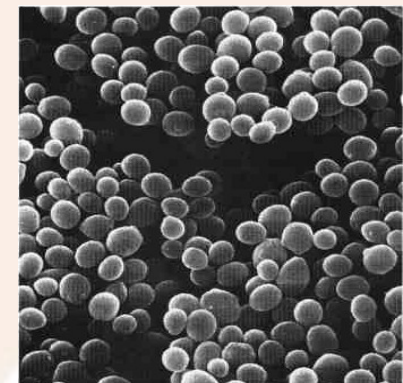
# Monitoring: Growth/increase of contaminant degrading organisms

**Aantallen *Dehalococcoides ethenogenes***

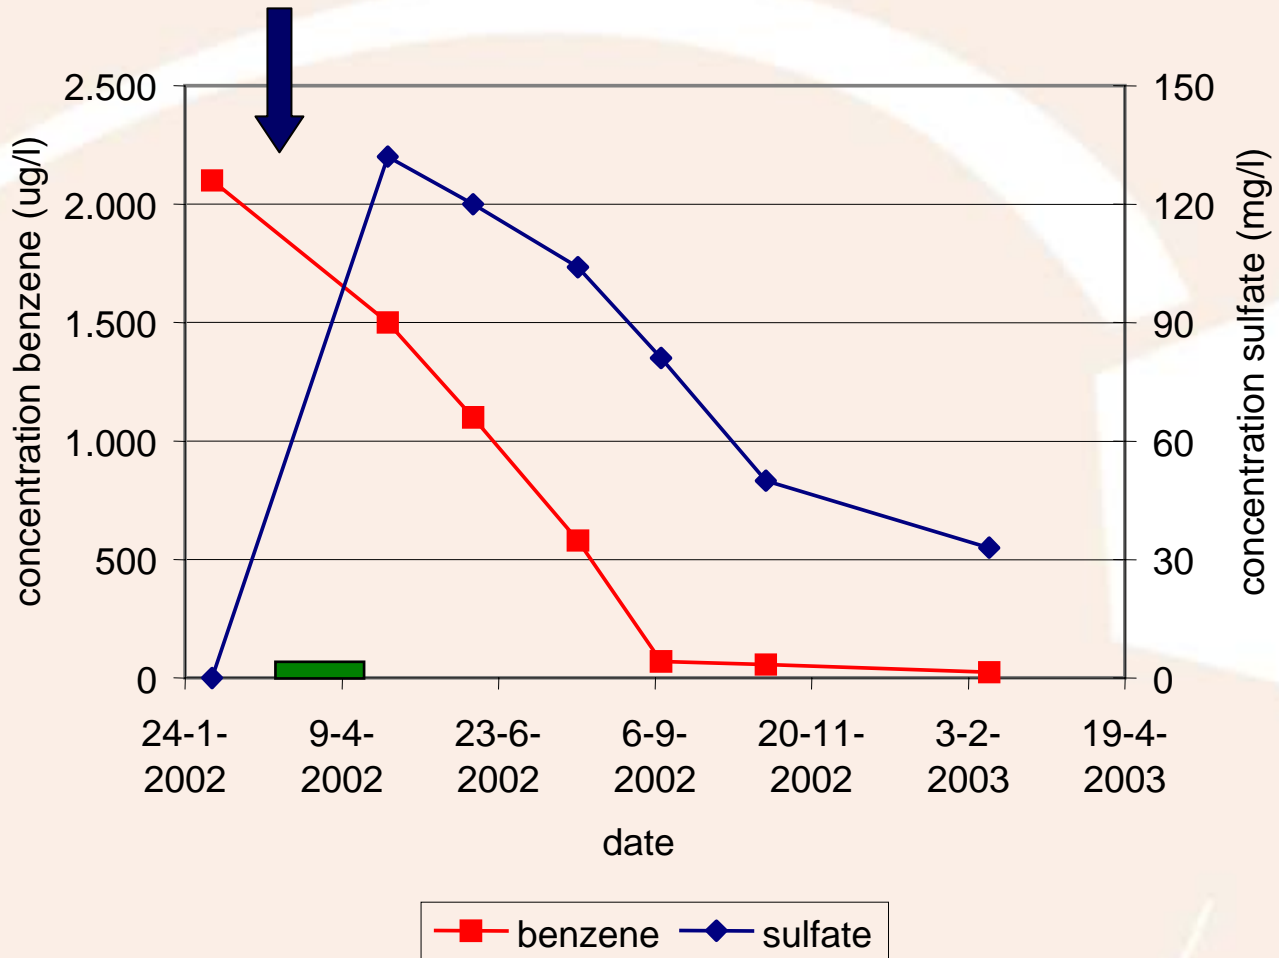
Direct injection of nitrate/sulfate at site

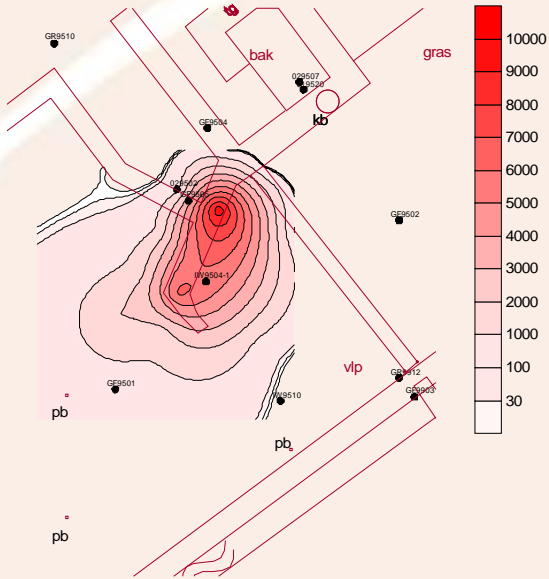
May 2002

Half life time benzene: 144 days

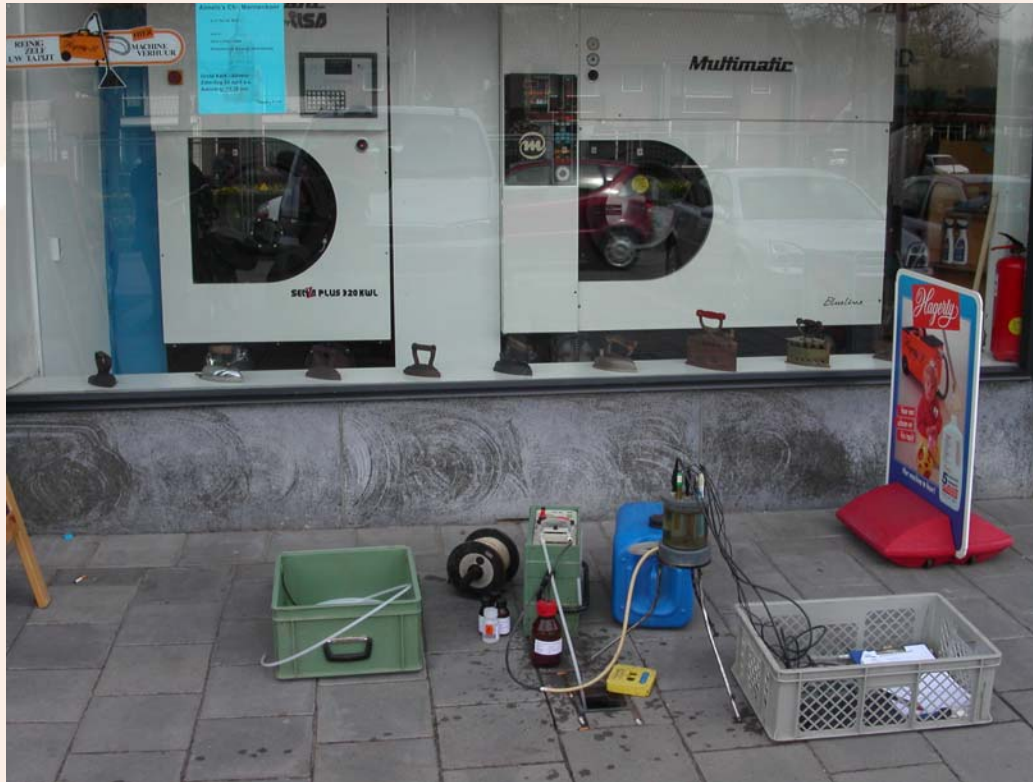
# Case Almelo (VOC)

T=0:

pH: 6.4-7.0

Sulfate: 75 –130 mg/l

PCE: 15,000 to several hundreds of  $\mu\text{g/l}$

TOC: 14-18 mg/l

No degrading organisms

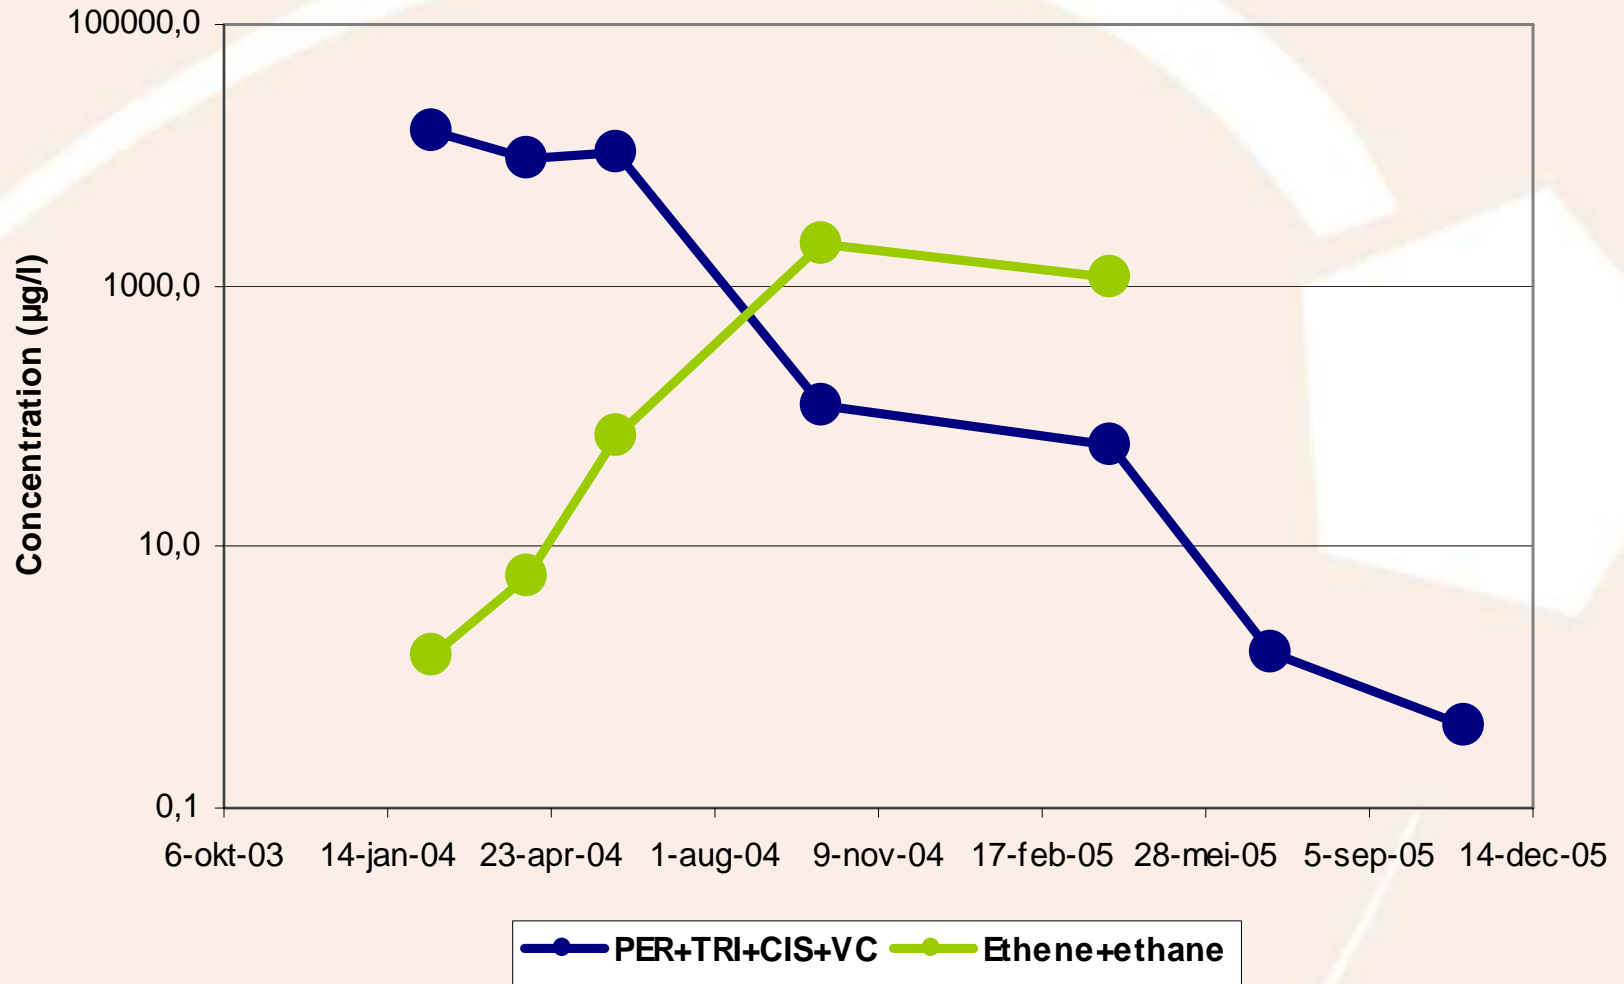
# Dechlorination

February 10, 2004	April 8, 2004	June 2, 2004	October 5, 2004	July 7, 2005	November 3, 2005
PCE (µg/l)	15.000	7.000	< 0,1	0,2	< 0,1	< 0,1
TCE (µg/l)	< 40	1.300	< 0,1	< 0,1	< 0,1	< 0,1
<i>cis</i> DCE (µg/l)	< 40	1.300	10.000	45	0,76	0,3
VC (µg/l)	< 40	NA	NA	23	0,8	0,13
Ethylene (µg/l)	0,2	4	57,9	2.100	NA	NA
Ethane (µg/l)	1,3	2	13,4	6.0	NA	NA
