Bioscreen

Monitoring,
molecular characterization and
emanation

TNO | Knowledge for business

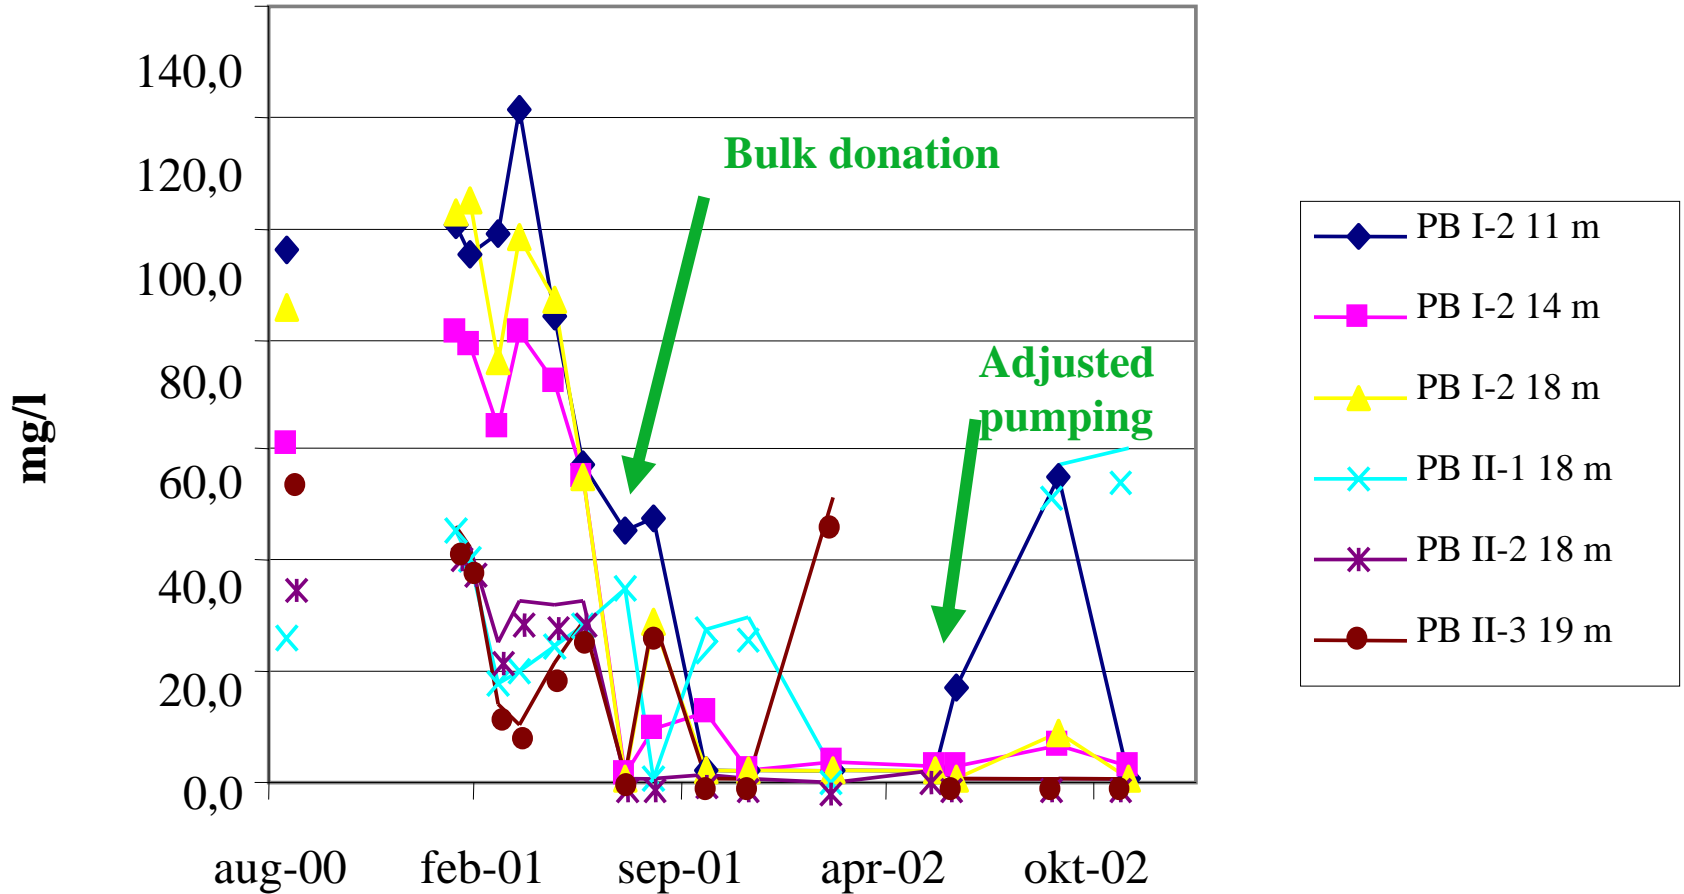
Example monitoring parameter as input for bioscreen operation : Sulfate

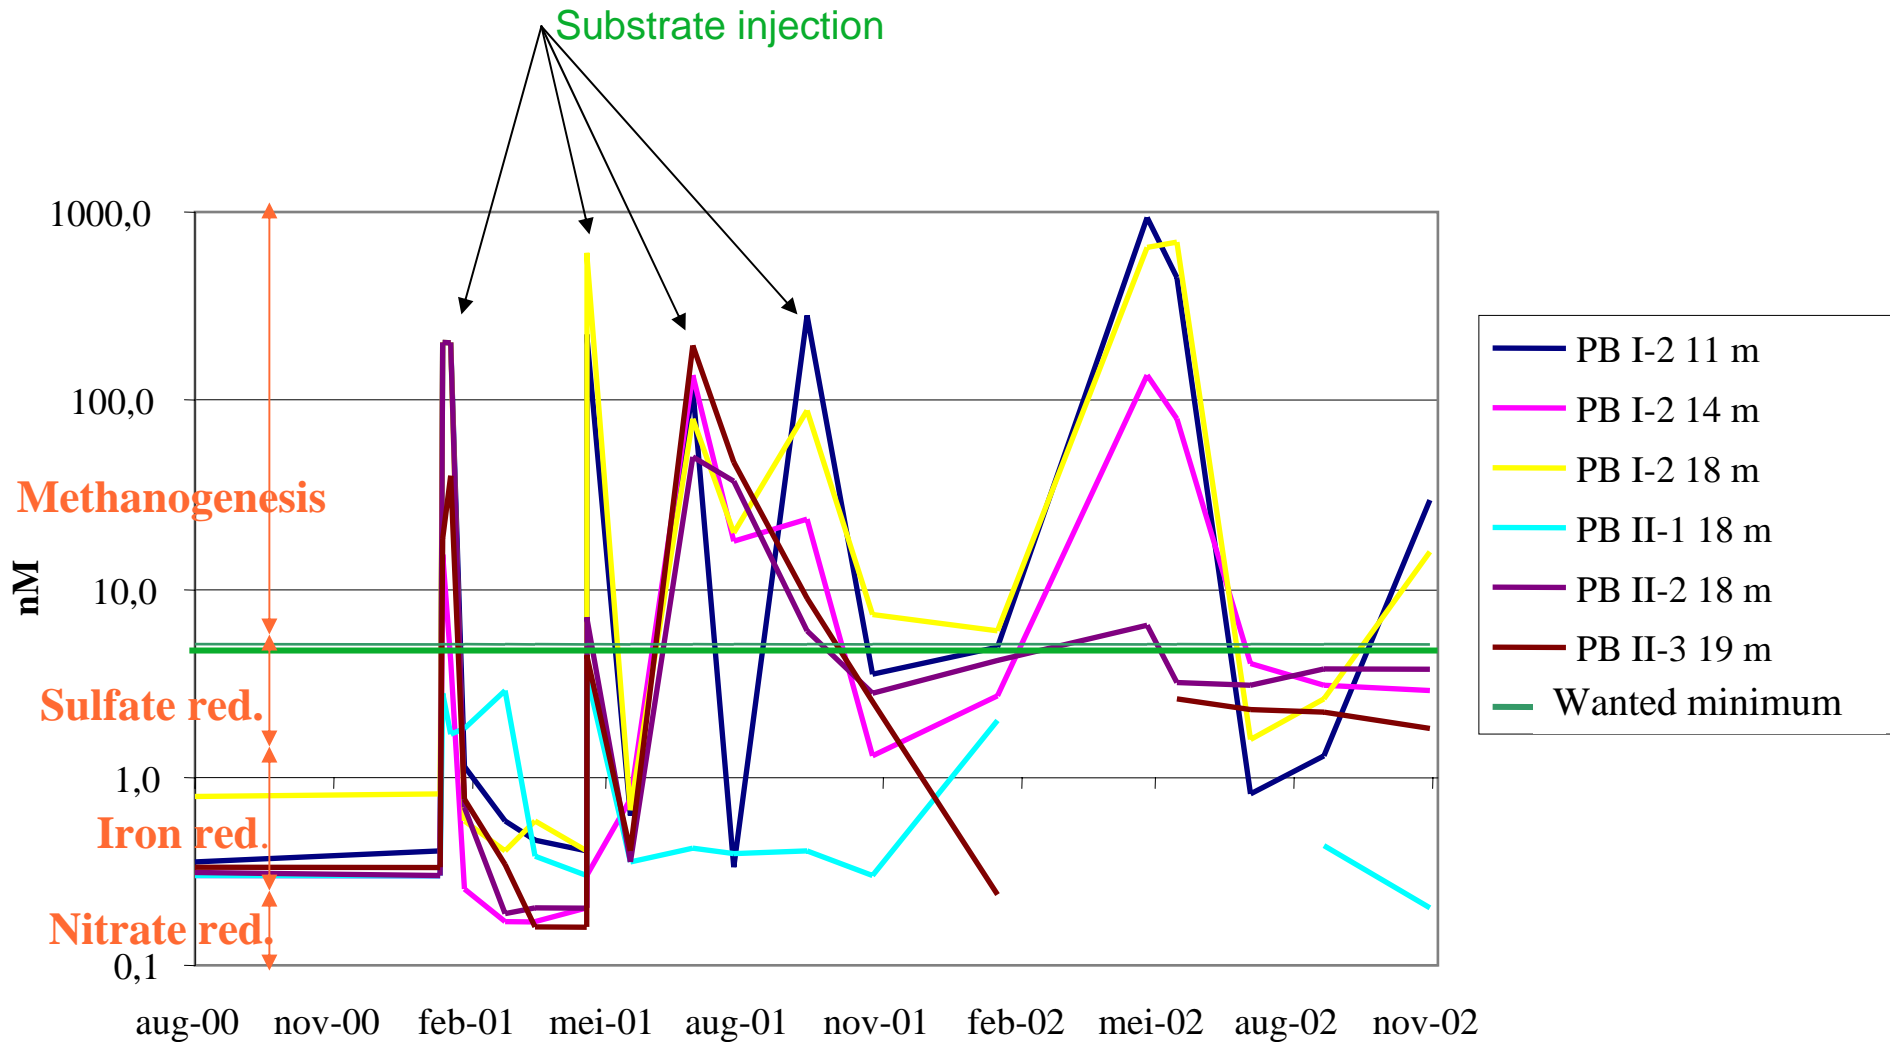
Hydrogen: very suitable for quick adjustments in injection regime of electron donor

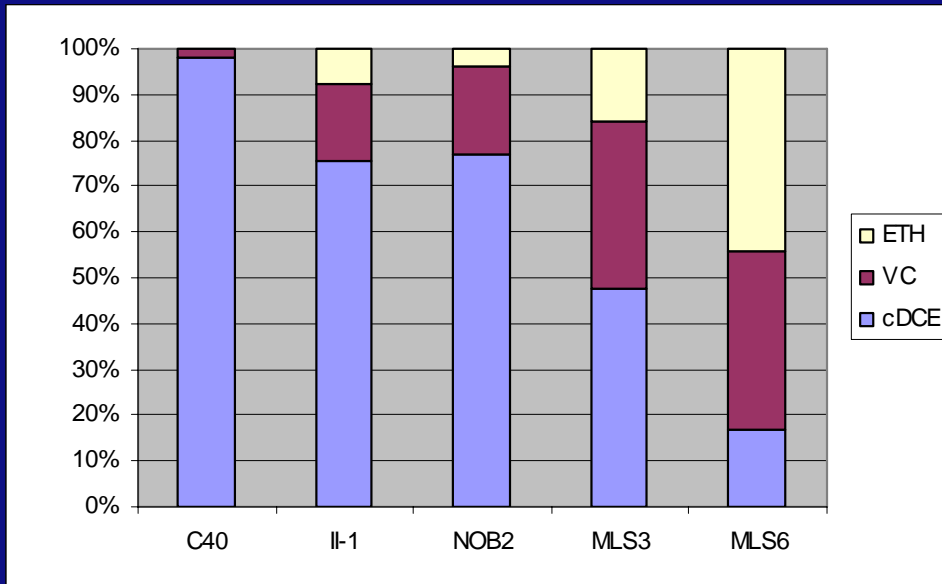
Degradation along flowpath?
